**Flood Control Project Maintenance  
Levee Inspections****LMA District Cover Sheet****Spring 2016 Levee Inspection Results****Reclamation District No. 0349 Sutter Island**

**Levee Inspection Report By Mile - Spring 2016**

**Reclamation District No. 0349 Sutter Island**

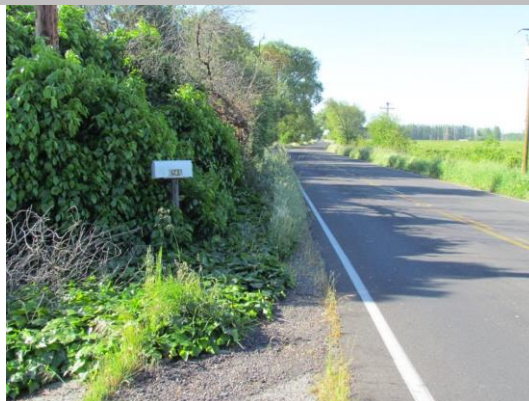
Photo 1 of 1 : SP\_2016\_RD0349\_204\_20\_20160405\_00025.jpg

LM Start	0.01	Rating **	U	Issue No.	20
LM End	0.94	Issue Type +	Ma	Location *	WS
Category	Earthen Levee			GPS Latitude/Longitude	
				Start	End
Item	Vegetation			38.327073 °	38.313798 °
				-121.576945 °	-121.578953 °
DWR ID	DWR_RD0349_01_s_2016_20				
Comment Code					
V2 : Remove the wild growth other than native grasses from the levee slopes.					
Inspector Comment					
Remove the unwanted tall weed growth from the levee section.

Looking downstream from levee mile 0.00 waterside shoulder and slope. Tall weeds has covered the levee section.

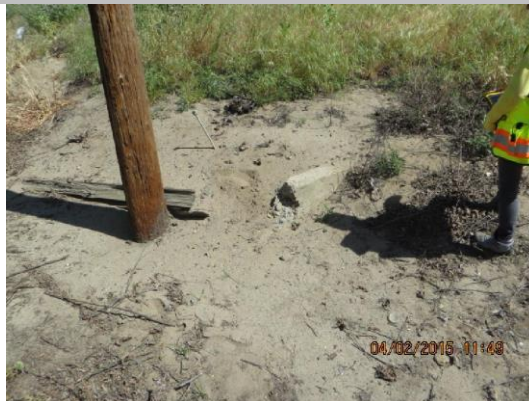
Photo 1 of 2 : UCIP\_SP\_2016\_44303\_73622.jpg

LM Start	0.08	Rating **	M	Issue No.	26
LM End	0.08	Issue Type +	En	Location *	WS
Category	Supplemental			GPS Latitude/Longitude	
				Start	End
Item	DWR UCIP Field Study			38.326133 °	38.326133 °
				-121.577141 °	-121.577141 °
DWR ID					
Comment Code					
Inspector Comment					
FS_ID:44303 DS_ID:24137 EP_NO: N/A Repair Type: Non-Urgent Crossing Status: Indicator Found UCIP Comments: Pipe appears to be abandoned and if so should be done so properly. Electromagnetic survey indicated a crossing at this location. FIELD_STRUCT_DESC: *ABANDONED* 10-inch pipe through the levee, 3.8 feet below the crown. Power pole and anchor on the landward side. Deteriorated concrete box at the LS toe. Concrete debris on WS toe good indicator of pump location (USACE-1960). This entry matches the Drainage or Irrigation Structure referenced in O&M manual (HLM 2.74). FS Date: 4/2/2015

Deteriorated concrete distribution box on LS toe next to power pole.

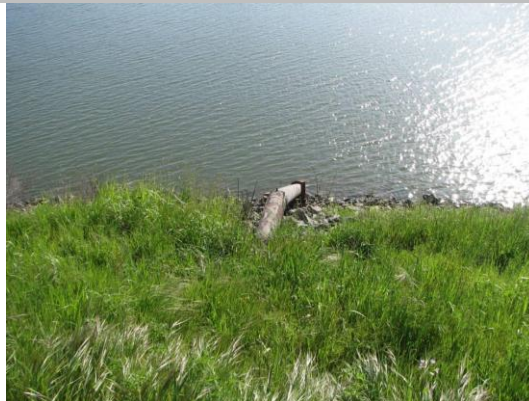
Photo 1 of 2 : UCIP\_SP\_2016\_39871\_36547.jpg

FS\_ID:39871  
DS\_ID:24139  
EP\_NO: N/A  
Repair Type: Urgent  
Crossing Status: Found  
UCIP Comments: Exposed section of levee slope on landward side--need to contact owner and DWR inspector. Burrow activity noticed at crossing 10 inch holes. Dense vegetation limits the inspector's visibility to identify signs of pipe failure (leaks) along the slope. Recommend removing vegetation along pipe alignment to conduct proper inspection of structure and appurtenances. Note date on photos should be 3/18/09 not 7/26/08 camera metadata is incorrect.  
FIELD\_STRUCT\_DESC: 8-inch steel pipe measured (instead of 10-inch) sleeved through a 12-inch steel pipe, 6.6 feet below the crown. Annular gap grouted at both ends. Active centrifugal pump on platform at landward toe. Inactive slant pump on steel platform on waterward slope. Exposed section pipe on waterward slope. Service pole on the landward slope. (USACE-1959). This entry matches the Drainage or Irrigation Structure referenced in O&M manual (HLM 0.5). 10-inch pipe sleeved through pre-existing pipe under Permit No. 3382 (1960). 12-inch pipe sleeved was authorized under Permit No. 951 in 1944.

View of pipe on waterward side with rip rap on toe--dense vegetation on slope.

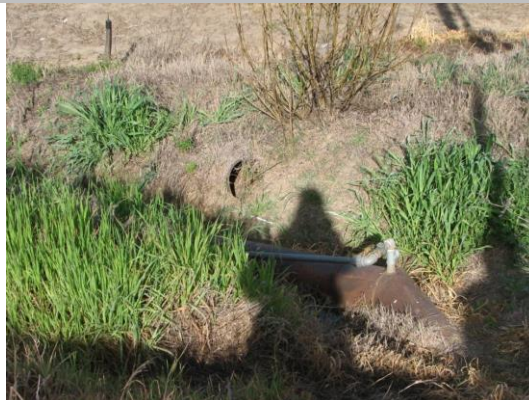
Photo 2 of 2 : UCIP\_SP\_2016\_39871\_36546.jpg

View of pipe on landward side--open cut section.

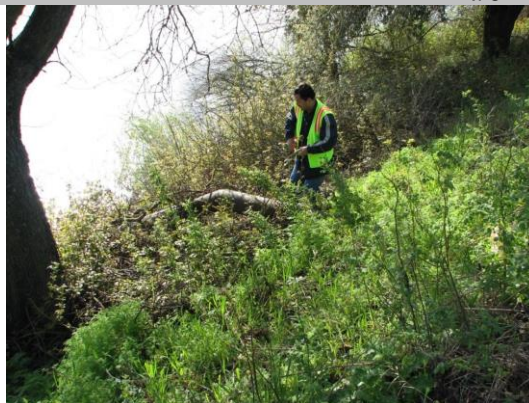
Photo 1 of 2 : UCIP\_SP\_2016\_21572\_36576.jpg

FS\_ID:21572  
DS\_ID:24521  
EP\_NO: N/A  
Repair Type: Non-Urgent  
Crossing Status: Found  
UCIP Comments: No records were found during initial desk study--need to contact owner to obtain permit number authorizing work. If crossing is no longer used by owner, the owner will need to coordinate with DWR Inspector and CVFPB to remove crossing according to Title 23 requirements. Dense vegetation limits the inspector's visibility to identify signs of pipe failure (leaks) along the slope. Recommend removing vegetation along pipe alignment to conduct proper inspection of structure and appurtenances. Note date on photos should be 3/18/09 not 7/26/08 camera metadata is incorrect.  
FIELD\_STRUCT\_DESC: Abandoned 8-inch pipe through the levee, 13.9 feet below the crown. Pump on platform at landward toe. Service pole on landward slope.  
FS Date: 3/18/2009

View of pipe crossing located on waterward side--dense vegetation on levee slope.

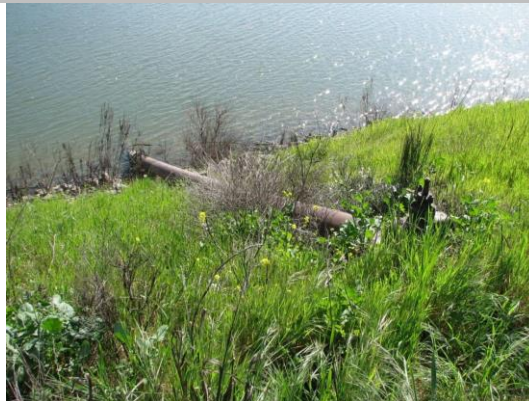
Photo 1 of 2 : UCIP\_SP\_2016\_39872\_36561.jpg

FS\_ID:39872  
DS\_ID:24140  
EP\_NO: N/A  
Repair Type: Urgent  
Crossing Status: Found  
UCIP Comments: Exposed section of levee slope on landward side-- need to contact owner and DWR inspector. Dense vegetation limits the inspector's visibility to identify signs of pipe failure (leaks) along the slope. Recommend removing vegetation along pipe alignment to conduct proper inspection of structure and appurtenances. Note date on photos should be 3/18/09 not 7/26/08 camera metadata is incorrect.  
FIELD\_STRUCT\_DESC: 14-inch pipe (waterward shoulder) and 12-inch pipe (landward shoulder) through the levee, 4.7 feet below the crown. Gate valve on the waterward slope. Pump in pumphouse on landward slope. Pressure breaker behind pumphouse. Pipe exposed on waterward slope. (USACE-1959). This entry matches the Drainage or Irrigation Structure referenced in O&M manual (HLM 1.1).  
FS Date: 3/18/2009

View of pipe on waterward side.

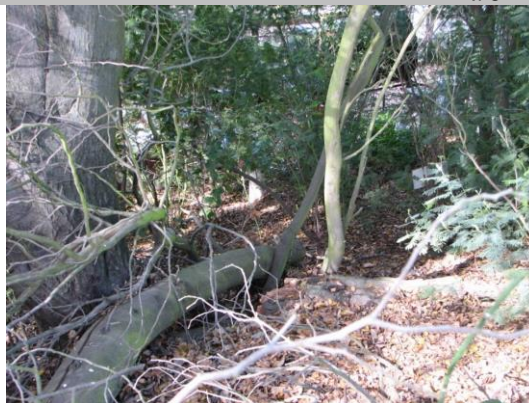
Photo 1 of 2 : UCIP\_SP\_2016\_44214\_36572.jpg

FS\_ID:44214  
DS\_ID:24143  
EP\_NO: 12005  
Repair Type: Non-Urgent  
Crossing Status: Found  
UCIP Comments: Pipe open on WS slope. 2007 Erosion Repair Site location?--Need to contact owner to determine if crossing is still in use. Dense vegetation limits the inspector's visibility to identify signs of pipe failure (leaks) along the slope. Recommend removing vegetation along pipe alignment to conduct proper inspection of structure and appurtenances. Note date on photos should be 3/18/09 not 7/26/08 camera metadata is incorrect.  
FIELD\_STRUCT\_DESC: 6-inch steel irrigation pipe, 4.0 feet below the crown. Siphon breaker and protective housing at levee shoulder. Pump on waterward side. Pipe exposed on waterward slope, extending to pump. Discharge structure at landward toe. (Permit No. 12005-1977)  
FS Date: 4/2/2015

View of landward side.

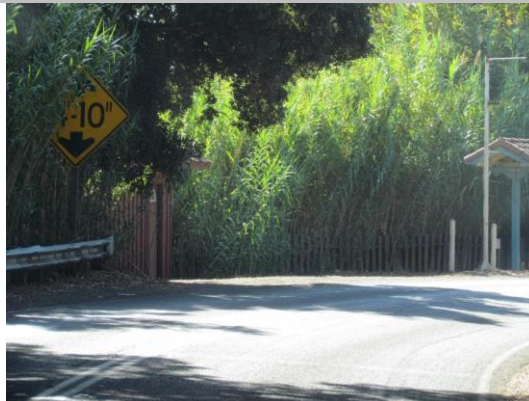
Photo 1 of 1 : SP\_2016\_RD0349\_204\_13\_20160223\_00006.jpg

LM Start	1.56	Rating **	U	Issue No.	13
LM End	1.58	Issue Type +	Ma	Location *	WS
Category	Earthen Levee			GPS Latitude/Longitude	
				Start	End
Item	Vegetation			38.305450 °	38.305162 °
				-121.574687 °	-121.574750 °
DWR ID	DWR_RD0349_01_f_2014_13				
Comment Code					
V2 : Remove the wild growth other than native grasses from the levee slopes.					
Inspector Comment					
This Arundo present on the waterward section is blocking the view of the levee section.

Unsatisfactory arundo completely covering the waterside shoulder and slope.

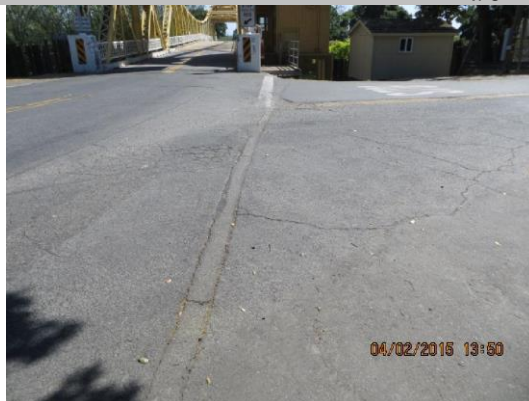
Photo 1 of 2 : UCIP\_SP\_2016\_46168\_74542.jpg

FS\_ID:46168  
DS\_ID:25096  
EP\_NO: N/A  
Repair Type: Non-Urgent  
Crossing Status: Indicator Found  
UCIP Comments: Need to identify permit for crossing.  
FIELD\_STRUCT\_DESC: 2-inch waterline through the levee at an unknown depth below crown. Pipe provides service to bridge and beach (per landowner).  
FS Date: 4/9/2015

Cut in pavement good indicator of pipe location.

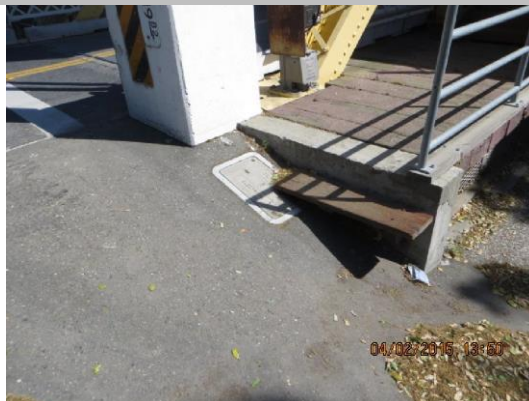
Photo 2 of 2 : UCIP\_SP\_2016\_46168\_74543.jpg

Christy box on WS shoulder.

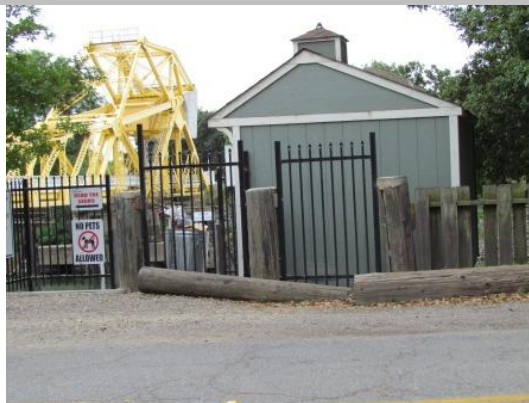
Photo 1 of 2 : SP\_2016\_RD0349\_205\_4\_20160223\_00005.jpg

Unauthorized building waterside shoulder; Unit 2 Sutter Slough.

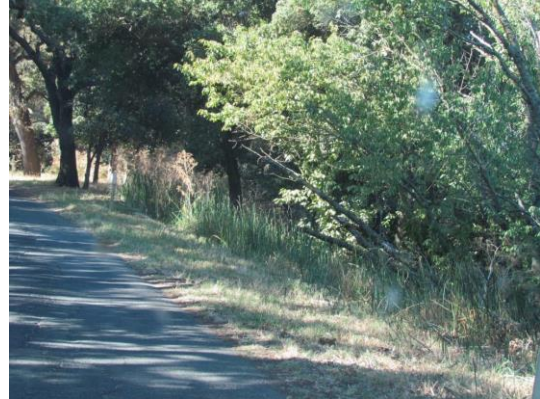
Photo 1 of 1 : SP\_2016\_RD0349\_205\_52\_20160223\_00014.jpg

LM Start	0.08	Rating **	U	Issue No.	52
LM End	0.20	Issue Type +	Ma	Location *	LS
Category	Earthen Levee			GPS Latitude/Longitude	
				Start	End
Item	Vegetation			38.304780 °	38.303738 °
				-121.576180 °	-121.577828 °
DWR ID	DWR_RD0349_02_f _ 2015_52				
Comment Code					
V1 : Control annual grass and weeds on the levee slopes and easements.					
Inspector Comment					
Remove the tall weeds and vegetation from the levee slope.

Looking downstream from landside shoulder at tall snapgrass and other vegetation on slope.

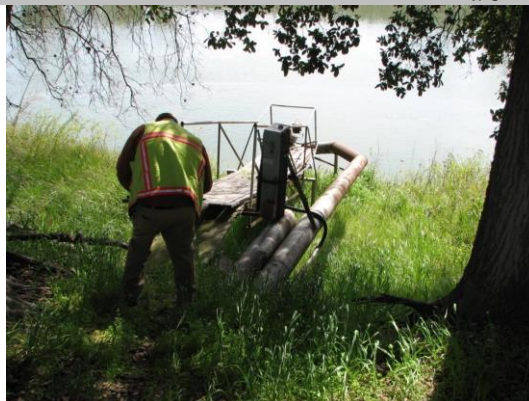
Photo 1 of 2 : UCIP\_SP\_2016\_21577\_36597.jpg

Comment Code						
Inspector Comment						
FS_ID:21577						
DS_ID:24146						
EP_NO: 2480						
Repair Type: Non-Urgent						
Crossing Status: Found						
UCIP Comments: Dense vegetation limits the inspector's visibility to identify signs of pipe failure (leaks) along the landward slope.						
Recommend removing vegetation along pipe alignment to conduct proper inspection of structure and appurtenances. Unable to determine if crossing is in use. Note date on photos should be 3/18/09 not 7/26/08 camera metadata is incorrect.						
FIELD_STRUCT_DESC: 10-inch steel pipe through the levee, 6.0 feet below the crown. Pump and slide gate on the waterward slope.						
Concrete pipe riser and distribution box with gate valve at the landward toe. Service pole and anchor on the landward slope. (Permit No. 2480-1959)						
FS Date: 3/18/2009

Dense vegetation on waterward slope-2 pipes and 1 conduit.

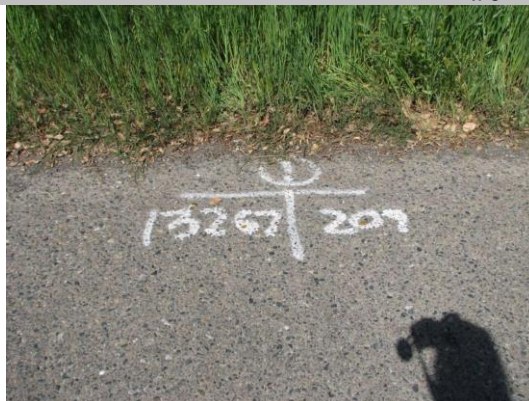
Photo 1 of 2 : UCIP\_SP\_2016\_21613\_36685.jpg

Underground service alert (USA) marking on levee crown.

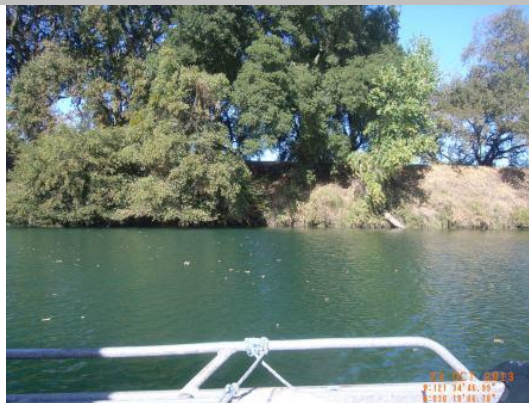
Photo 1 of 1 : SP\_2016\_RD0349\_205\_9\_20160223\_00007.jpg

LM Start	0.34	Rating **	M	Issue No.	9
LM End	0.39	Issue Type +	Ma	Location *	WS
Category	Supplemental			GPS Latitude/Longitude	
				Start	End
Item	2015 USACE Erosion Survey, DRAFT			38.302358 °	38.301772 °
				-121.579707 °	-121.580093 °
DWR ID	DWR_RD0349_02_s _ 2016_9				
Comment Code					
Inspector Comment					
2007 - Slow erosion, probably due to wave wash and fluvial erosion. Site has likely been here for awhile but was unseen due to boats parked in front. 2015: Large tree popout, scarp reaches crown of levee. [2015 Site ID: STM_25-8_R]

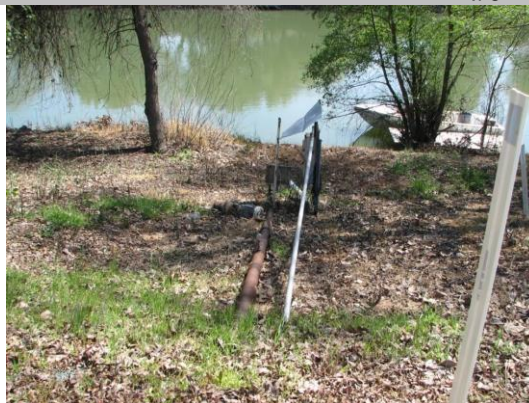
Photo 1 of 2 : UCIP\_SP\_2016\_21615\_36694.jpg

View of pipe and pump on waterward side.

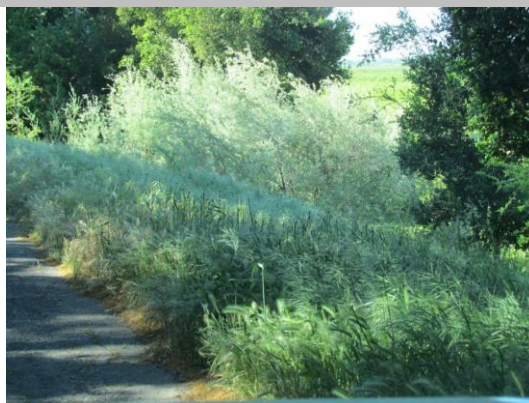
Photo 1 of 1 : SP\_2016\_RD0349\_205\_51\_20160411\_00079.jpg

LM Start	0.78	Rating **	U	Issue No.	51
LM End	0.78	Issue Type +	Ma	Location *	LS
Category	Earthen Levee			GPS Latitude/Longitude	
				Start	End
Item	Vegetation			38.296543 °	38.296543 °
				-121.582612 °	-121.582612 °
DWR ID	DWR_RD0349_02_s_2016_51				
Comment Code					
V1 : Control annual grass and weeds on the levee slopes and easements.					
Inspector Comment					
Remove the unwanted young willow trees from the levee slope landside.

Looking downstream from levee mile 0.78 young tall willow trees present on the slope.

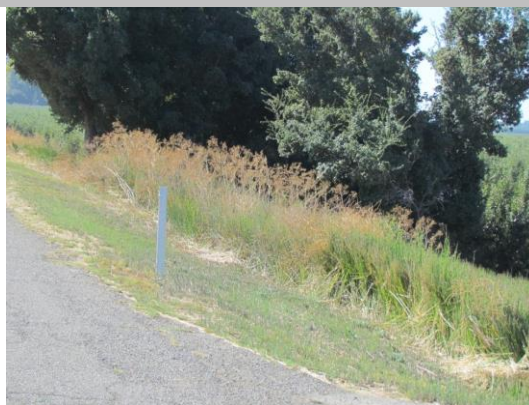
Photo 1 of 1 : SP\_2016\_RD0349\_205\_14\_20160223\_00011.jpg

LM Start	1.07	Rating **	U	Issue No.	14
LM End	1.30	Issue Type +	Ma	Location *	LS
Category	Earthen Levee			GPS Latitude/Longitude	
				Start	End
Item	Vegetation			38.292457 °	38.289063 °
				-121.583898 °	-121.584057 °
DWR ID	DWR_RD0349_02_f_2015_14				
Comment Code					
V1 : Control annual grass and weeds on the levee slopes and easements.					
Inspector Comment					
Remove the snap grass from the landward slope.

Looking downstream from levee mile 1.07 to 1.30 snap grasses covering landward slope.

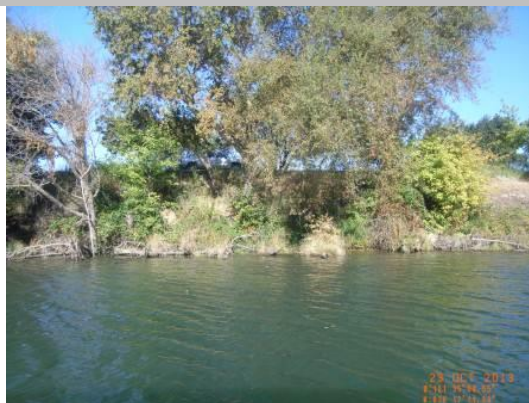
Photo 1 of 1 : SP\_2016\_RD0349\_205\_10\_20160223\_00008.jpg

Comment Code					
Inspector Comment					
1997 - Erosion of very sandy levee behind large stand of riparian vegetation on top right bank. Dry ravel of sand. 1999 - Quarry waste rock was dumped down the levee slope; poor repair job; still eroding in places. Eroding at midslope off fabric. 2005 - Length revised, only the middle 150 - 200 ft are eroding. 2006 - Some rock/small material dumped down the bank but it is slowly unraveling. Upstream end is unraveling faster. Steep slope with poor gradation so fines are washing out. 2010 - Lots of overhanging trees and erosion pockets. 2011 - This site is upgraded to CRITICAL. Near vertical bank at the downstream end. New erosion at various locations throughout the site. 2015: No observed changes. [2015 Site ID: STM_24-7_R]

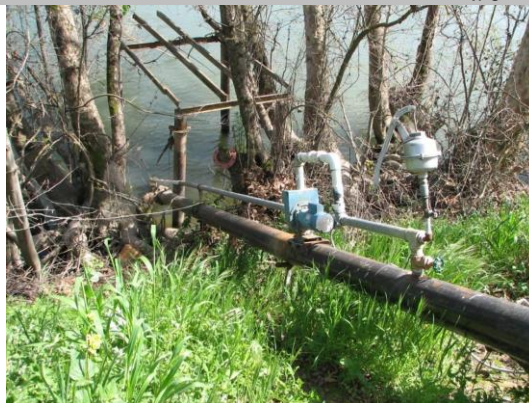
Photo 1 of 2 : UCIP\_SP\_2016\_21606\_36655.jpg

View of abandoned framing located on river's edge.

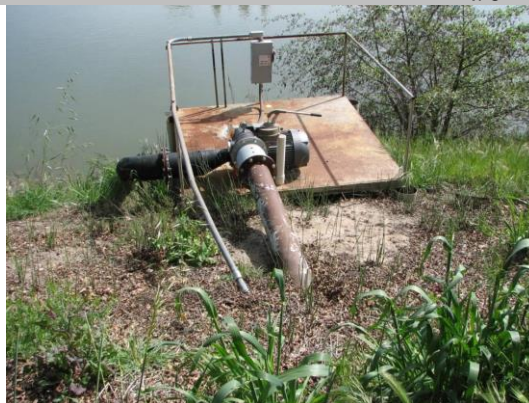
Photo 1 of 2 : UCIP\_SP\_2016\_21607\_36661.jpg

View of waterward side.

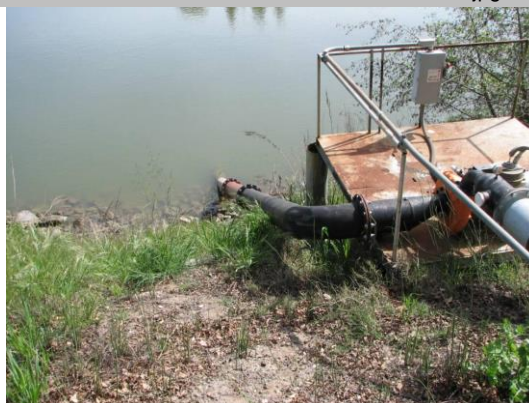
Photo 2 of 2 : UCIP\_SP\_2016\_21607\_36659.jpg

Pipe at the waterward toe.

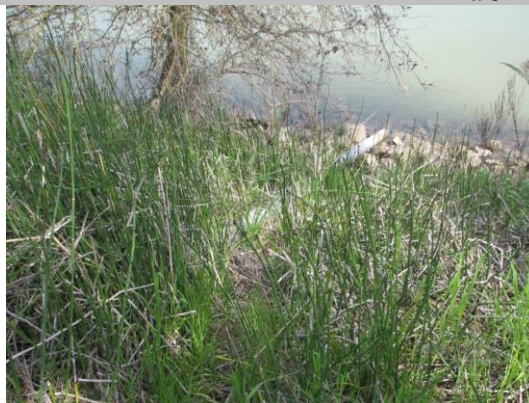
Photo 1 of 2 : UCIP\_SP\_2016\_21608\_36662.jpg

View of pipe on waterward slope.

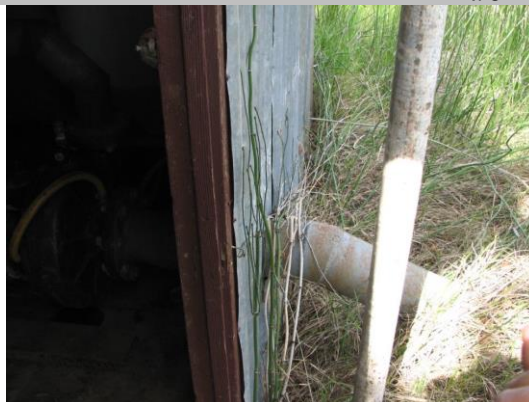
Photo 2 of 2 : UCIP\_SP\_2016\_21608\_36663.jpg

View of pipe daylight at shed on waterward side.

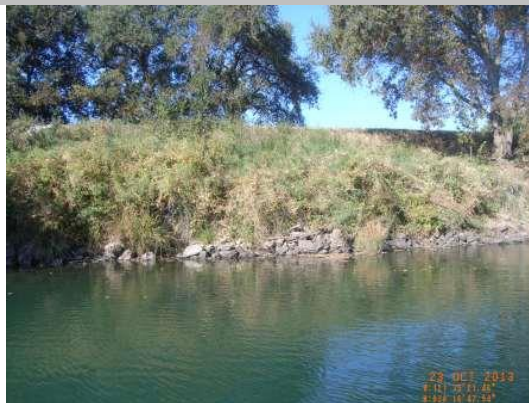
Photo 1 of 1 : SP\_2016\_RD0349\_205\_19\_20160223\_00013.jpg

LM Start	2.04	Rating **	M	Issue No.	19
LM End	2.05	Issue Type +	Ma	Location *	WS
Category	Supplemental			GPS Latitude/Longitude	
				Start	End
Item	2015 USACE Erosion Survey, DRAFT			38.280069 °	38.279919 °
				-121.589443 °	-121.589438 °
DWR ID	DWR_RD0349_02_s_2016_19				
Comment Code					
Inspector Comment					
2011 - Small scallop caused by erosion and wave wash. 2015: No observed changes. [2015 Site ID: STM_24-1_R]

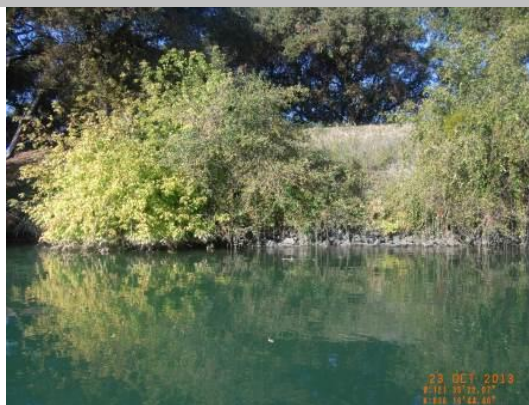
Photo 1 of 1 : SP\_2016\_RD0349\_205\_16\_20160223\_00012.jpg

LM Start	2.11	Rating **	M	Issue No.	16
LM End	2.14	Issue Type +	Ma	Location *	WS
Category	Supplemental			GPS Latitude/Longitude	
				Start	End
Item	2015 USACE Erosion Survey, DRAFT			38.279017 °	38.278597 °
				-121.589615 °	-121.589854 °
DWR ID	DWR_RD0349_02_s_2016_16				
Comment Code					
Inspector Comment					
1997 - Top right bank has retreated into the levee. Site is between two rock sites. 1999 - Downstream half of the reach repaired with rock. 2000 - Trees leaning into the water. 2010 - Site appears worse. 2011 - New erosion at the toe. 2013 - Short vertical sections observed at upstream end. 2015: Minor new erosion. [2015 Site ID: STM_23-9_R]

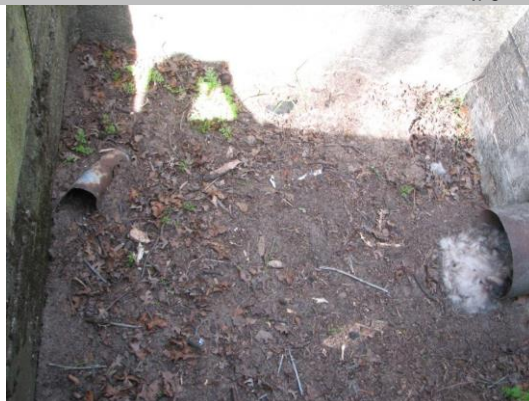
Photo 1 of 2 : UCIP\_SP\_2016\_21609\_36668.jpg

Inside view of distribution box located on landward side.

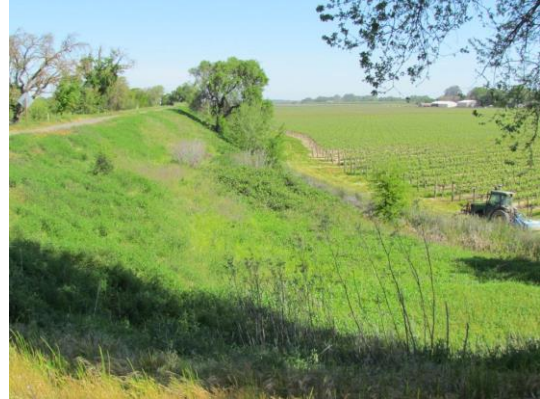
Photo 1 of 1 : SP\_2016\_RD0349\_205\_64\_20160511\_00087.jpg

LM Start	2.36	Rating **	U	Issue No.	64
LM End	4.30	Issue Type +	Ma	Location *	LS
Category	Earthen Levee			GPS Latitude/Longitude	
				Start	End
Item	Vegetation			38.275795 °	38.254703 °
				-121.591428 °	-121.599703 °
DWR ID	DWR_RD0349_02_s_2016_64				
Comment Code					
V2 : Remove the wild growth other than native grasses from the levee slopes.					
Inspector Comment					
The wild weeds on the landside slope and toe needs to be maintained.

RD 349 Unit 2 looking downstream from levee mile 2.36 to 4.30 at tall grasses and other wild growth on the slope and toe.

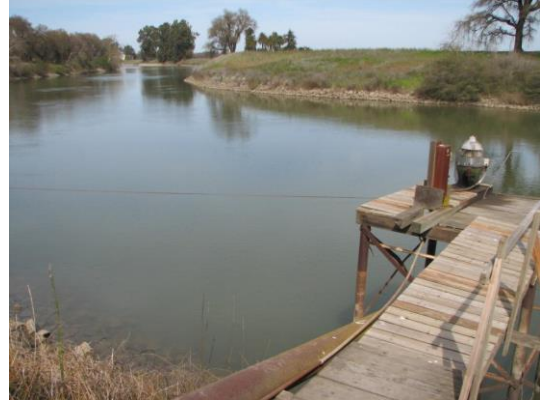
Photo 1 of 2 : UCIP\_SP\_2016\_39873\_36678.jpg

Comment Code					
Inspector Comment					
FS_ID:39873 DS_ID:24158 EP_NO: N/A Repair Type: Non-Urgent Crossing Status: Found UCIP Comments: Dense vegetation limit the inspector's visibility to identify signs of pipe failure (leaks) through the levee slopes. Recommend removing vegetation along pipe alignment to conduct proper inspection of structure and appurtenances. FIELD_STRUCT_DESC: 12-inch pipe through the levee, 4.0 feet below the crown. Pump on pile structure on waterward side, walkway to pump. Concrete distribution box and power pole with anchor at landward toe. Concrete standpipe on landward side. (Permit No. 946, 1944). This entry matches the Drainage or Irrigation Structure referenced in O&M manual (HLM 2.5). FS Date: 3/18/2009

View of waterward side--pump and control panel located on raised platform.

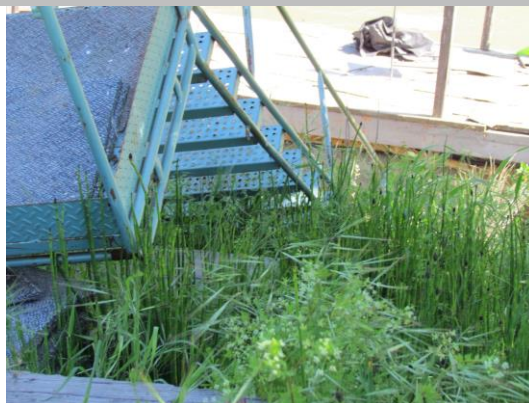
Photo 1 of 2 : SP\_2016\_RD0349\_205\_1\_20160422\_00083.jpg

LM Start	2.39	Rating **	U	Issue No.	1
LM End	2.39	Issue Type +	En	Location *	WS
Category	Earthen Levee			GPS Latitude/Longitude	
				Start	End
Item	Encroachments			38.275403 °	38.275403 °
				-121.591229 °	-121.591229 °
DWR ID	DWR_RD0349_02_f_2013_1				
Comment Code					
ST : Stairway					
Inspector Comment					
The landowner has installed steps on the waterside slope and has an unauthorized boat dock anchored to the waterside slope.

Metal steps and boat dock levee mile 2.39.

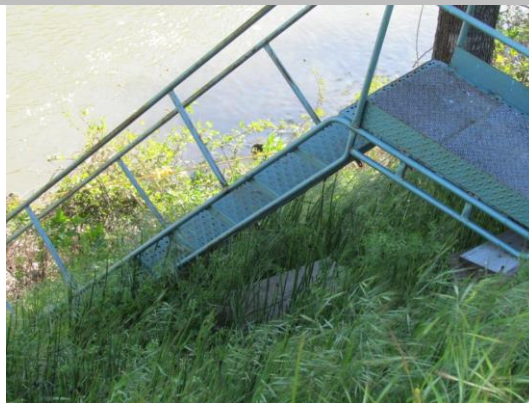
Photo 2 of 2 : SP\_2016\_RD0349\_205\_1\_20160422\_00084.jpg

LM Start	2.39	Rating **	U	Issue No.	1 (cont)	
LM End	2.39	Issue Type +	En	Location *	WS	
Category	Earthen Levee			GPS Latitude/Longitude		
				Start		End
Item	Encroachments			38.275403 °		38.275403 °
				-121.591229 °		-121.591229 °
DWR ID	DWR_RD0349_02_f_2013_1					
Comment Code						
ST : Stairway						
Inspector Comment						
The landowner has installed steps on the waterside slope and has an unauthorized boat dock anchored to the waterside slope.

Unauthorized metal steps on the waterside slope levee mile 2.39.

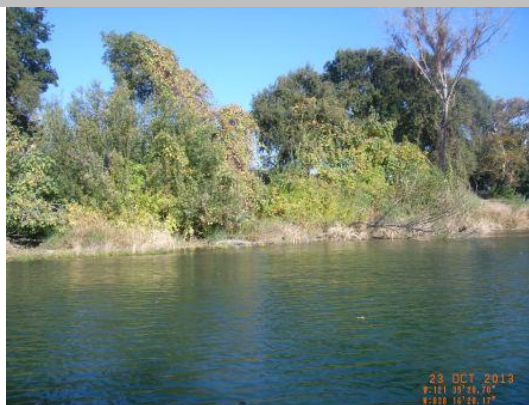
Photo 1 of 2 : SP\_2016\_RD0349\_205\_3\_20160223\_00003.jpg

LM Start	2.56	Rating **	M	Issue No.	3
LM End	2.69	Issue Type +	Ma	Location *	WS
Category	Supplemental			GPS Latitude/Longitude	
				Start	End
Item	2015 USACE Erosion Survey, DRAFT			38.273854 °	38.271998 °
				-121.588745 °	-121.589424 °
DWR ID	DWR_RD0349_02_s_2016_3				
Comment Code					
Inspector Comment					
2011 - Toe scour at the tidal zone. 2015: New tree popout and minor new erosion. [2015 Site ID: STM_23-6_R]

USACE 2013 Photo #1

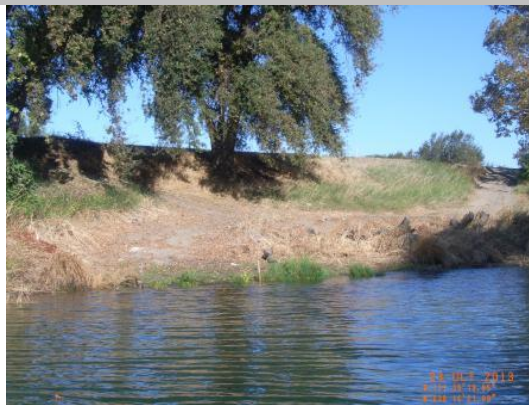
Photo 2 of 2 : SP\_2016\_RD0349\_205\_3\_20160223\_00004.jpg

LM Start	<b>2.56</b>	Rating **	M	Issue No.	<b>3 (cont)</b>
LM End	<b>2.69</b>	Issue Type +	Ma	Location *	WS

USACE 2013 Photo #2

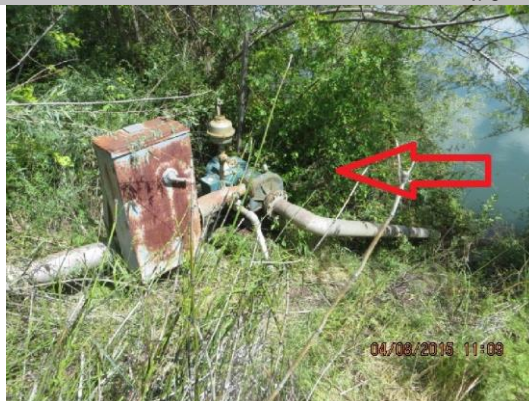
Photo 1 of 2 : UCIP\_SP\_2016\_44331\_73709.jpg

FS\_ID:44331  
DS\_ID:24160  
EP\_NO: N/A  
Repair Type: Urgent  
Crossing Status: Found  
UCIP Comments: Pipe visible on WS slope and appears to be open. Pipe needs to be properly abandoned or verified as having been done so properly.  
FIELD\_STRUCT\_DESC: \*ABANDONED\* 8-inch pipe through the levee, 3.7 feet below the crown. Pump on concrete blocks on the waterward slope. (Permit No. 655-1935). This entry matches the Drainage or Irrigation Structure referenced in O&M manual (HLM 3.2). Pipe removed from slopes under Permit No. 5350 when new pipe was installed in 1966 . Pipe section through crown appears to have been left in place.  
FS Date: 4/8/2015

Abandoned pipe visible on slope in vegetation behind new pipe on WS slope.

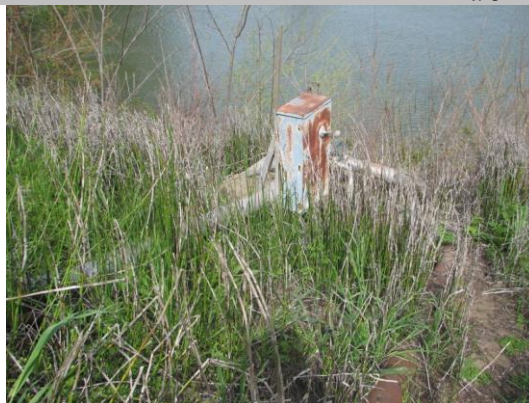
Photo 1 of 2 : UCIP\_SP\_2016\_44332\_36679.jpg

FS\_ID:44332  
DS\_ID:24199  
EP\_NO: 5350  
Repair Type: Non-Urgent  
Crossing Status: Found  
UCIP Comments: Need to contact owner to determine if crossing is still in use. If crossing is no longer in use owner will need to coordinate with DWR inspector and CVFPB to remove according to Title 23 requirements. Debris scattered on slopes--remove. Dense vegetation limits the inspector's visibility to identify signs of pipe failure (leaks) along the slope. Recommend removing vegetation along pipe alignment to conduct proper inspection of structure and appurtenances. Unable to determine if crossing is in use. Note date on photos should be 3/18/09 not 7/26/08 camera metadata is incorrect.  
FIELD\_STRUCT\_DESC: 6-inch steel pipe and 2-inch iron electrical conduit through the levee, both 3.7 feet below the crown. Siphon breaker in pipe riser on waterward slope. Pump, switch panel, and butterfly valve on concrete blocks on the waterward slope. Service pole on landward slope (Permit No. 5350-1966).

View of waterward side--control panel, pipe, pump, and butterfly valve on WS slope.

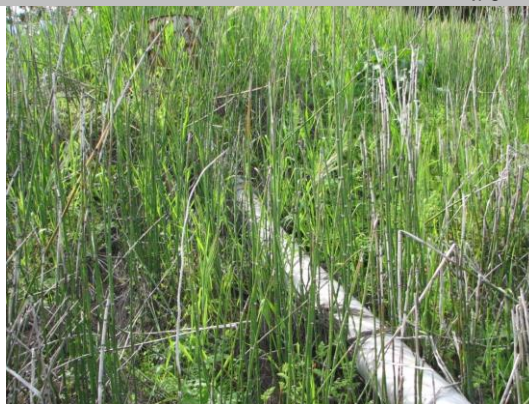
Photo 2 of 2 : UCIP\_SP\_2016\_44332\_36681.jpg

Pipe and Steel riser on WS slope.

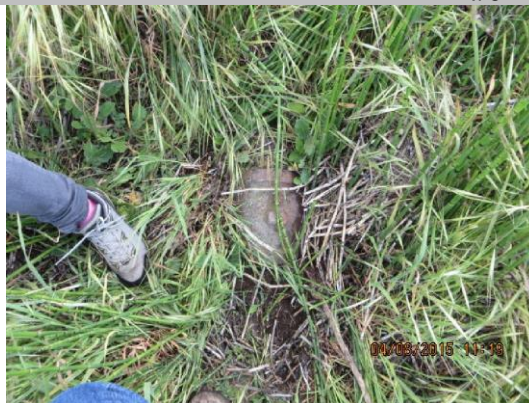
Photo 1 of 2 : UCIP\_SP\_2016\_46172\_74553.jpg

LM Start	3.15	Rating **	M	Issue No.	99
LM End	3.15	Issue Type +	En	Location *	LS
Category	Supplemental			GPS Latitude/Longitude	
				Start	End
Item	DWR UCIP Field Study			38.265608 °	38.265608 °
				-121.588391 °	-121.588391 °
DWR ID					
Comment Code					
Inspector Comment					
FS_ID:46172 DS_ID:25099 EP_NO: N/A Repair Type: Non-Urgent Crossing Status: Found UCIP Comments: Appears abandoned and if so should be verified as having been done so properly. FIELD_STRUCT_DESC: Abandoned 6-inch pipe through the levee, 4.5 feet below the crown. Service pole at landward toe. FS Date: 4/2/2015

Pipe just visible on LS slope.

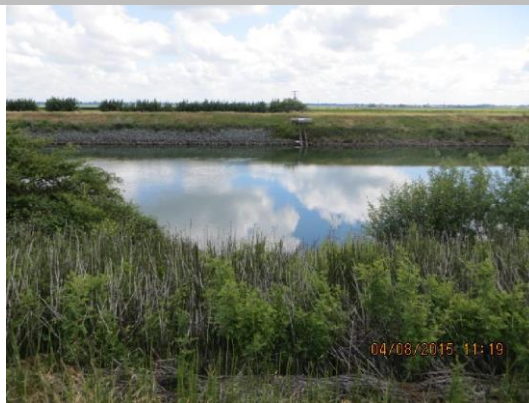
Photo 2 of 2 : UCIP\_SP\_2016\_46172\_74554.jpg

View of WS from shoulder at crossing. Pipe not found on WS.

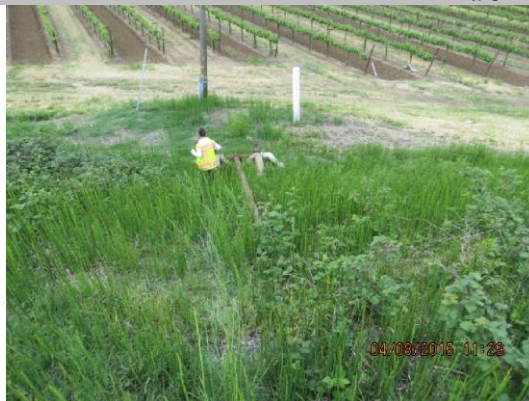
Photo 1 of 2 : UCIP\_SP\_2016\_44333\_73713.jpg

LM Start	3.31	Rating **	M	Issue No.	103
LM End	3.31	Issue Type +	En	Location *	LS
Category	Supplemental			GPS Latitude/Longitude	
				Start	End
Item	DWR UCIP Field Study			38.263359 °	38.263359 °
				-121.588721 °	-121.588721 °
DWR ID					
Comment Code					
Inspector Comment					
FS_ID:44333					
DS_ID:24161					
EP_NO: N/A					
Repair Type: Non-Urgent					
Crossing Status: Found					
UCIP Comments: Pipe appears abandoned and if so should be done so properly.					
FIELD_STRUCT_DESC: Abandoned 6-inch pipe through the levee, 4.5 feet below the crown. Pump and switch panel on the waterward slope. Service pole and concrete distribution box at landward toe. (USACE-1959). This entry matches the Drainage or Irrigation Structure referenced in O&M manual (HLM 3.5).					
FS Date: 4/8/2015

Pipe, distribution box, and power pole visible on LS slope/toe.

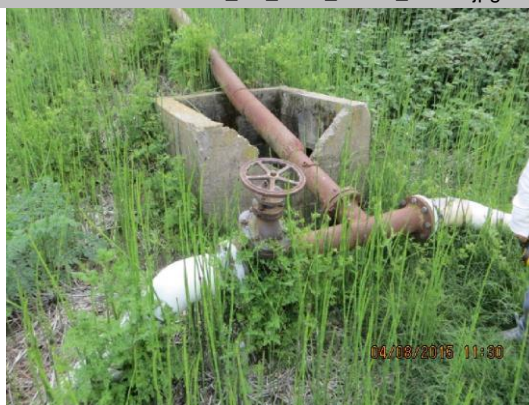
Photo 2 of 2 : UCIP\_SP\_2016\_44333\_73712.jpg

distribution box and pipe visible on LS toe.

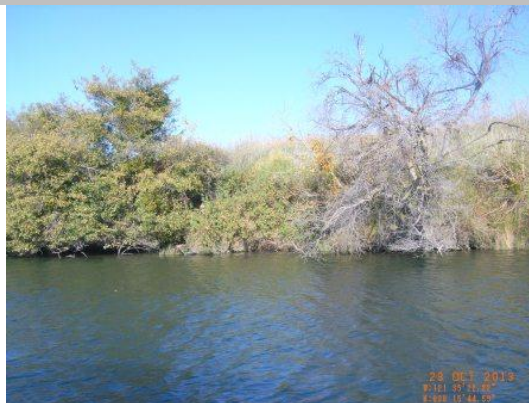
Photo 1 of 1 : SP\_2016\_RD0349\_205\_11\_20160223\_00009.jpg

LM Start	3.38	Rating **	M	Issue No.	11
LM End	3.49	Issue Type +	Ma	Location *	WS
Category	Supplemental			GPS Latitude/Longitude	
				Start	End
Item	2015 USACE Erosion Survey, DRAFT			38.262510 °	38.262533 °
				-121.589481 °	-121.591690 °
DWR ID	DWR_RD0349_02_s_2016_11				
Comment Code					
Inspector Comment					
2010 - Slumping sections on the lower bank, appears to be scouring around the trees. 2011 - Soil beach at toe. 2015: No observed changes. [2015 Site ID: STM_22-8_R]

USACE 2013 Photo #1

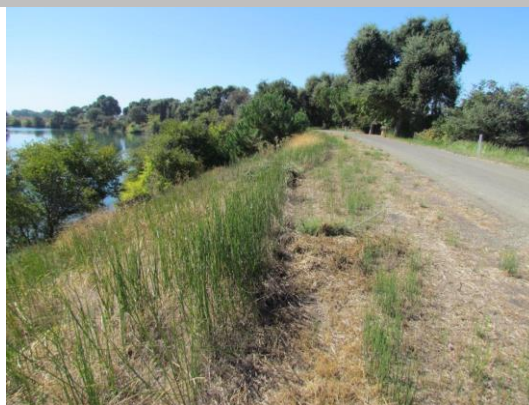
Photo 1 of 1 : SP\_2016\_RD0349\_205\_84\_20160223\_00022.jpg

LM Start	3.58	Rating **	U	Issue No.	84
LM End	4.31	Issue Type +	Ma	Location *	WS
Category	Earthen Levee			GPS Latitude/Longitude	
				Start	End
Item	Vegetation			38.262588 °	38.254733 °
				-121.593328 °	-121.599963 °
DWR ID	DWR_RD0349_02_f_2015_84				
Comment Code					
V2 : Remove the wild growth other than native grasses from the levee slopes.					
Inspector Comment					
Remove the snap grasses from the waterside levee slope.

Tall snap grasses covering the waterward slope.

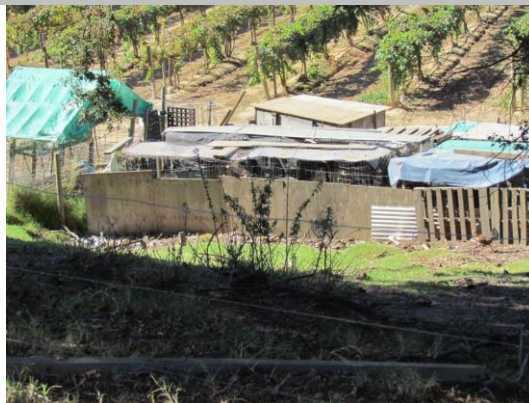
Photo 2 of 4 : SP\_2016\_RD0349\_205\_59\_20160223\_00016.jpg

LM Start	3.76	Rating **	U	Issue No.	59 (cont)	
LM End	3.91	Issue Type +	En	Location *	LS	
Category	Earthen Levee			GPS Latitude/Longitude		
				Start		End
Item	Encroachments			38.260596 °	38.258426 °	
				-121.592160 °	-121.595125 °	
DWR ID	DWR_RD0349_02_f_2013_59					
Comment Code						
FE : Fence						
Inspector Comment						
Inside the fenced off area are several pet shelters and pens for chickens and goats on the landside levee slope and toe. This need to be taken off the levee section. In the event of a flood fight this area would cause delays in response time.

Unauthorized electric wire fence, solid board fence and animal storages within the 10-foot easement landside levee toe.

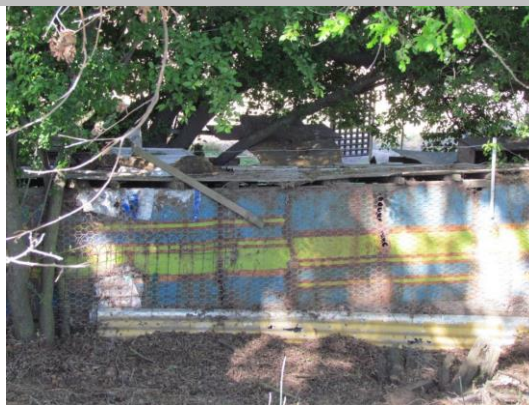
Photo 3 of 4 : SP\_2016\_RD0349\_205\_59\_20160422\_00086.jpg

Unauthorized animal storage pens within the landside easement.

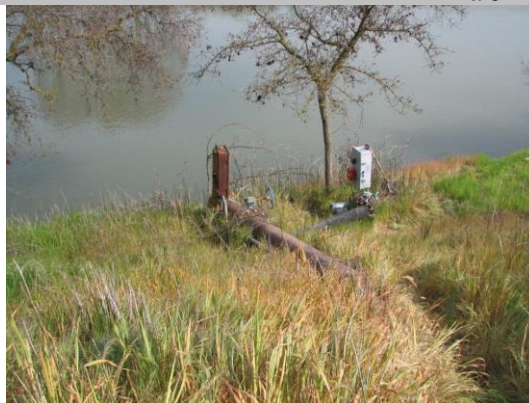
Photo 1 of 2 : UCIP\_SP\_2016\_21612\_36684.jpg

FS\_ID:21612  
DS\_ID:24162  
EP\_NO: 8188  
Repair Type: Non-Urgent  
Crossing Status: Found  
UCIP Comments: Dense vegetation limits the inspector's visibility to identify signs of pipe failure (leaks) along the landward slope. Recommend removing vegetation along pipe alignment to conduct proper inspection of structure and appurtenances. Unable to determine if crossing is in use. Note date on photos should be 3/18/09 not 7/26/08 camera metadata is incorrect.  
FIELD\_STRUCT\_DESC: 12-inch steel irrigation pipe and 1.25-inch electrical conduit through the levee, both 5.0 feet below the crown. Steel cutoff wall around pipe at center of levee. Siphon breaker on shoulder. Pump and pumphouse on the waterward side. Service pole, discharge box and concrete standpipe at landward toe. (Permit No. 8188-1973)  
FS Date: 3/18/2009

Overview of waterward side--2 crossings.

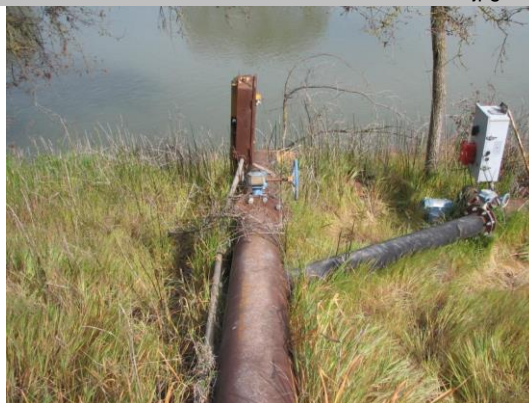
Photo 2 of 2 : UCIP\_SP\_2016\_21612\_36682.jpg

View of crossing on waterward side.

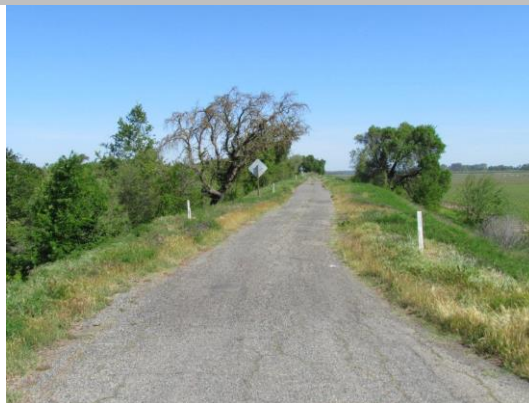
Photo 1 of 1 : SP\_2016\_RD0349\_206\_51\_20160510\_00076.jpg

LM Start	0.00	Rating **	U	Issue No.	51
LM End	1.53	Issue Type +	Ma	Location *	LS
Category	Earthen Levee			GPS Latitude/Longitude	
				Start	End
Item	Vegetation			38.254733 °	38.276008 °
				-121.599963 °	-121.601003 °
DWR ID	DWR_RD0349_03_f_2015_51				
Comment Code					
V1 : Control annual grass and weeds on the levee slopes and easements.					
Inspector Comment					
Remove the unwanted wild growth from the landside levee slope and toe.

Looking downstream from levee mile 0.00-1.53 landside slope and shoulder.

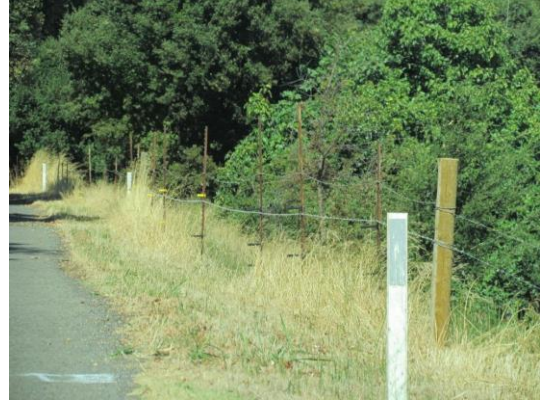
Photo 1 of 1 : SP\_2016\_RD0349\_206\_53\_20160223\_00004.jpg

LM Start	0.69	Rating **	U	Issue No.	53
LM End	0.80	Issue Type +	En	Location *	LS
Category	Earthen Levee			GPS Latitude/Longitude	
				Start	End
Item	Encroachments			38.264615 °	38.266097 °
				-121.601382 °	-121.601822 °
DWR ID	DWR_RD0349_03_f_2015_53				
Comment Code					
FE : Fence					
Inspector Comment					
Remove the unauthorized electric fence from the landside shoulder and slope.

Unauthorized electric wire fence on the shoulder and slope landside.

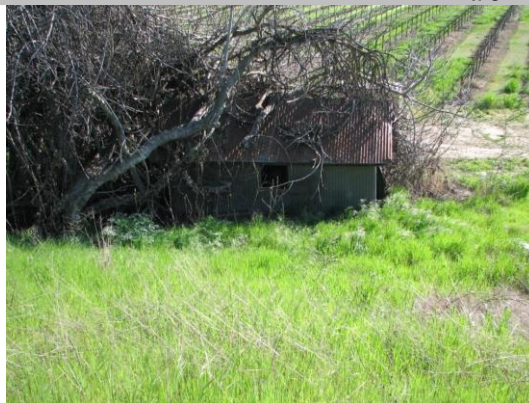
Photo 2 of 2 : UCIP\_SP\_2016\_43442\_36706.jpg

Item	DWR UCIP Field Study			38.265751 °	38.265751 °	
				-121.601655 °	-121.601655 °	
DWR ID						
Comment Code						
Inspector Comment						
FS_ID:43442						
DS_ID:24163						
EP_NO: N/A						
Repair Type: Non-Urgent						
Crossing Status: Found						
UCIP Comments: Need to find owner and notify of pipe deterioration.						
Owner will need to replace or remove per CVFPB Title 23 requirements.						
Dense vegetation limits the inspector's visibility to identify signs of pipe						
failure (leaks) through the levee slopes. Recommend removing						
vegetation along pipe alignment to conduct proper inspection of						
structure and appurtenances. Note date on photos should be 3/18/09						
not 7/26/08 camera metadata is incorrect.						
FIELD_STRUCT_DESC: 8-inch steel irrigation pipe through the levee,

2.4 feet below the crown. Pump and gate valve in a pumphouse at the						
landward toe. Concrete standpipe on landward side.						
FS Date: 3/19/2009

Pump house located at the landward toe.

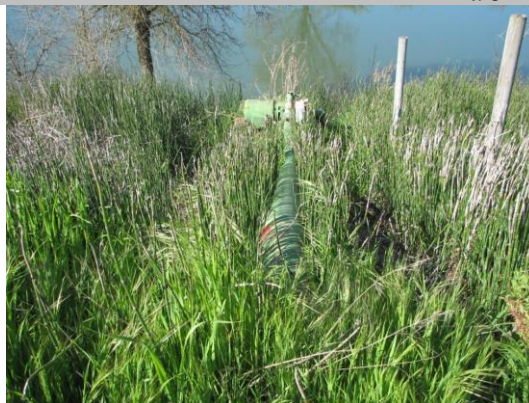
Photo 1 of 2 : UCIP\_SP\_2016\_21673\_36851.jpg

FS\_ID:21673  
DS\_ID:24232  
EP\_NO: N/A  
Repair Type: Non-Urgent  
Crossing Status: Found  
UCIP Comments: No records were found during initial desk study--need to contact owner to obtain permit number authorizing work. Unable to determine if filter system is part of crossing appurtenances. If crossing is no longer used by owner, the owner will need to coordinate with DWR Inspector and CVFPB to remove crossing according to Title 23 requirements. Dense vegetation limits the inspector's visibility to identify signs of pipe failure (leaks) through the levee slopes. Recommend removing vegetation along pipe alignment to conduct proper inspection of structure and appurtenances. Note date on photos should be 3/18/09 not 7/26/08 camera metadata is incorrect.  
FIELD\_STRUCT\_DESC: 12-inch pipe through the levee, approximately 2.0 feet below the crown. Pipe changes diameter, 10-inch along both shoulders and 8-inch diameter exit on waterward side. Pipe exposed along both slopes. Pump on waterward side. Filtration system and power pole on landward side. Rock revetment on waterward slope.

View of waterward side--pipe and pump.

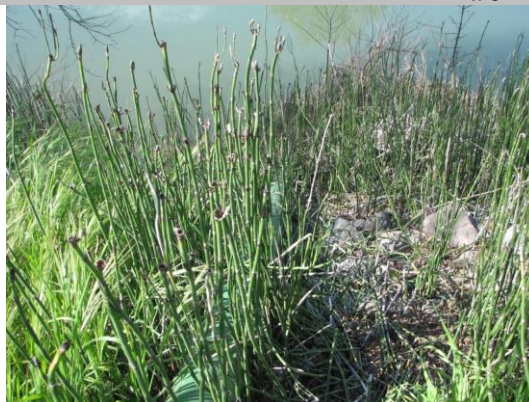
Photo 2 of 2 : UCIP\_SP\_2016\_21673\_36853.jpg

View of pipe crossing past pump station.

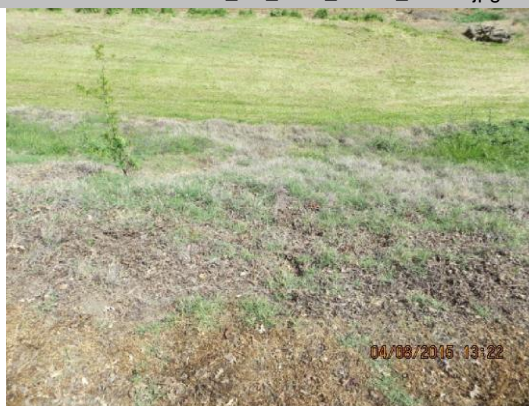
Photo 1 of 2 : UCIP\_SP\_2016\_44335\_73721.jpg

LM Start	1.17	Rating **	M	Issue No.	987
LM End	1.17	Issue Type +	En	Location *	WS
Category	Supplemental			GPS Latitude/Longitude	
				Start	End
Item	DWR UCIP Field Study			38.271218 °	38.271218 °
				-121.603468 °	-121.603468 °
DWR ID					
Comment Code					
Inspector Comment					
FS_ID:44335					
DS_ID:24166					
EP_NO: N/A					
Repair Type: Non-Urgent					
Crossing Status: Found					
UCIP Comments: Pipe abandoned and should be done so properly or verified as having been done so properly.					
FIELD_STRUCT_DESC: 6-inch pipe through the levee, 4.5 feet below the crown. Pump and pumphouse no longer on the landward toe. (USACE-1959). This entry matches the Drainage or Irrigation Structure referenced in O&M manual (HLM 1.2).					
FS Date: 4/9/2015

Pipe visible on LS slope.

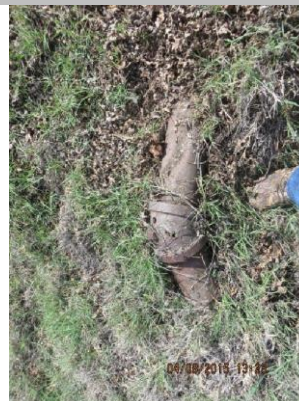
Photo 2 of 2 : UCIP\_SP\_2016\_44335\_73720.jpg

LM Start	1.17	Rating **	M	Issue No.	987 (cont)	
LM End	1.17	Issue Type +	En	Location *	WS	
Category	Supplemental			GPS Latitude/Longitude		
				Start	End	
Item	DWR UCIP Field Study			38.271218 °	38.271218 °	
				-121.603468 °	-121.603468 °	
DWR ID						
Comment Code						
Inspector Comment						
FS_ID:44335						
DS_ID:24166						
EP_NO: N/A						
Repair Type: Non-Urgent						
Crossing Status: Found						
UCIP Comments: Pipe abandoned and should be done so properly or verified as having been done so properly.						
FIELD_STRUCT_DESC: 6-inch pipe through the levee, 4.5 feet below the crown. Pump and pumphouse no longer on the landward toe. (USACE-1959). This entry matches the Drainage or Irrigation Structure referenced in O&M manual (HLM 1.2).						
FS Date: 4/9/2015

Pipe visible on LS slope.

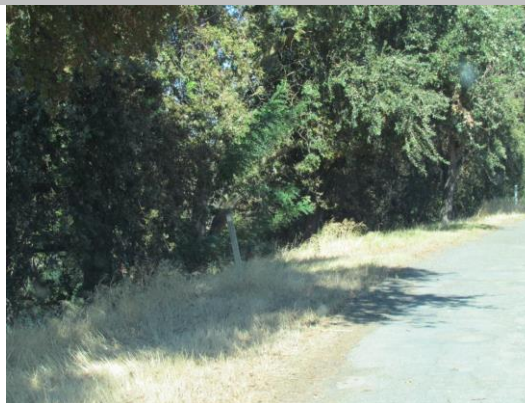
Photo 1 of 1 : SP\_2016\_RD0349\_206\_54\_20160223\_00005.jpg

LM Start	1.22	Rating **	U	Issue No.	54
LM End	1.69	Issue Type +	Ma	Location *	WS
Category	Earthen Levee			GPS Latitude/Longitude	
				Start	End
Item	Vegetation			38.271910 °	38.278318 °
				-121.603358 °	-121.600343 °
DWR ID	DWR_RD0349_03_f_2015_54				
Comment Code					
V1 : Control annual grass and weeds on the levee slopes and easements.					
Inspector Comment					
Remove the unwanted woody tree growth from the waterside levee section. No new picture.

Looking downstream from the waterside levee shoulder and slope woody tree growth blocking the view of the levee section.

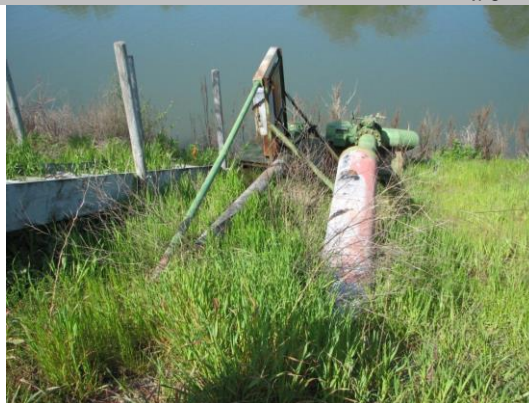
Photo 1 of 1 : UCIP\_SP\_2016\_47043\_36864.jpg

Comment Code					
Inspector Comment					
FS_ID:47043 DS_ID:24169 EP_NO: 11744 Repair Type: Non-Urgent Crossing Status: Found UCIP Comments: Dense vegetation limits the inspector's visibility to identify signs of pipe failure (leaks) through the levee slopes. Recommend removing vegetation along pipe alignment to conduct proper inspection of structure and appurtenances. Note date on photos should be 3/18/09 not 7/26/08 camera metadata is incorrect. FIELD_STRUCT_DESC: 1 of 2: 8-inch pipe through the levee, 3.7 feet below the crown. 8-inch pipe is reduced to 3-inch pipe on waterward side. Steel cutoff wall around pipe at center of levee. Siphon breaker at landward shoulder. Siphon breaker at landward shoulder. Slant pump on waterward side. Discharge structure at landward toe. Rock revetment on waterward slope. (Permit No. 11744-1976) FS Date: 3/19/2009

View of pipe, control panel, and stairs. 2 pipes go through levee 14-inch and 8-inch.

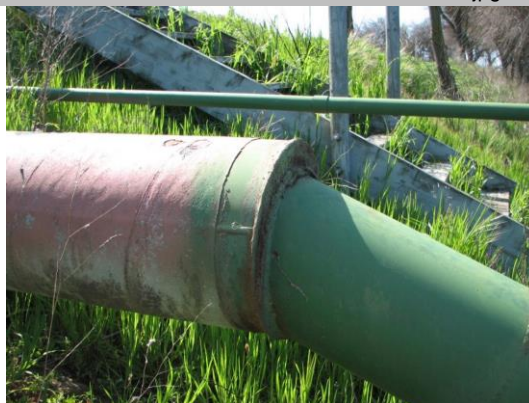
Photo 2 of 2 : UCIP\_SP\_2016\_47042\_36857.jpg

FS\_ID:47042  
DS\_ID:24168  
EP\_NO: 11744  
Repair Type: Non-Urgent  
Crossing Status: Found  
UCIP Comments: Dense vegetation limits the inspector's visibility to identify signs of pipe failure (leaks) through the levee slopes. Recommend removing vegetation along pipe alignment to conduct proper inspection of structure and appurtenances. Note date on photos should be 3/18/09 not 7/26/08 camera metadata is incorrect.  
FIELD\_STRUCT\_DESC: 2 of 2: 14-inch steel irrigation pipe and 2-inch electric conduit through the levee, both 4.4 feet below the crown. Reduced to 12-inch steel pipe under both levee slopes. Steel cutoff wall around pipe at center of levee. Siphon breaker at landward shoulder. Slant pump on waterward side with staircase access. Discharge structure at landward toe. Rock revetment on waterward slope. (Permit No. 11744-1976)  
FS Date: 3/19/2009

Pipe reduced from 14-inch to 10-inch and conduit through levee.

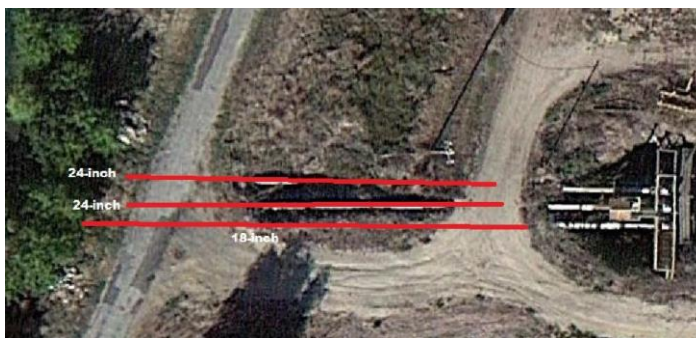
Photo 1 of 2 : UCIP\_SP\_2016\_43446\_36725.jpg

Inspector Comment
FS_ID:43446 DS_ID:24229 EP_NO: 2954 Repair Type: Non-Urgent Crossing Status: Found UCIP Comments: Dense vegetation limits the inspector's visibility to identify signs of pipe failure (leaks) through the levee slopes. Recommend removing vegetation along pipe alignment to conduct proper inspection of structure and appurtenances. Note date on photos should be 3/18/09 not 7/26/08 camera metadata is incorrect. FIELD_STRUCT_DESC: [R.D. No. 349 Drainage Pumping Plant] 1 of 3: 18-inch pipe through the levee, 7.8 feet below the crown. Siphon breakers on waterward slope. Pumps on platform on landward side. FS Date: 3/19/2009

Aerial map showing alignment of 18-inch pipe.

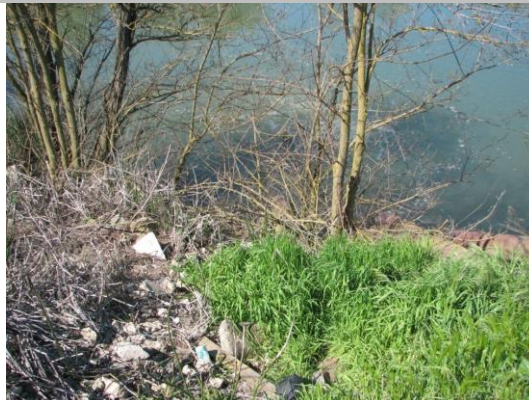
Photo 2 of 2 : UCIP\_SP\_2016\_43446\_36726.jpg

View of all 3 pipes through levee and visible on waterward toe.

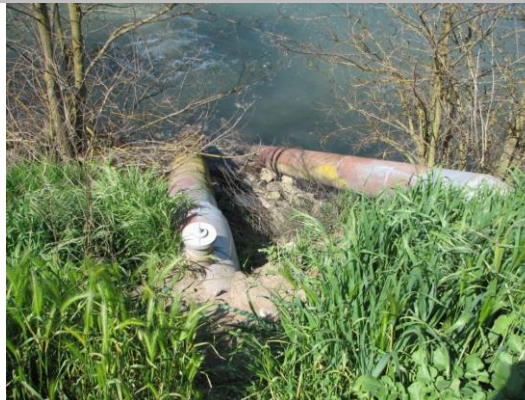
Photo 2 of 2 : UCIP\_SP\_2016\_43445\_36727.jpg

Inspector Comment
FS_ID:43445 DS_ID:24228 EP_NO: 2954 Repair Type: Non-Urgent Crossing Status: Found UCIP Comments: Dense vegetation limits the inspector's visibility to identify signs of pipe failure (leaks) along the slope. Recommend removing vegetation along pipe alignment to conduct proper inspection of structure and appurtenances. Note date on photos should be 3/18/09 not 7/26/08 camera metadata is incorrect. FIELD_STRUCT_DESC: [R.D. No. 349 Drainage Pumping Plant] 2 of 3: 24-inch pipe through the levee, 7.8 feet below the crown. Siphon breakers on waterward slope. Pumps on platform on landward side. FS Date: 3/19/2009

View of pipe on waterward side--pipe running. Siphon breaker visible on pipe.

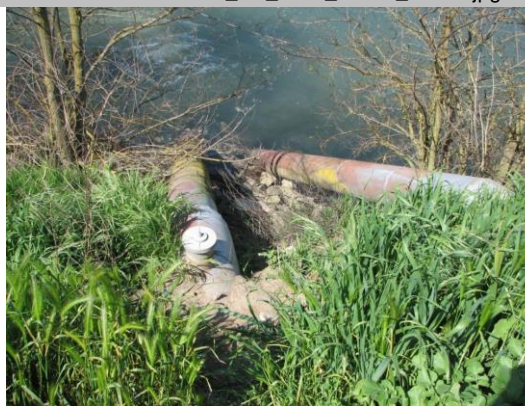
Photo 2 of 2 : UCIP\_SP\_2016\_21632\_36731.jpg

FS\_ID:21632  
DS\_ID:24171  
EP\_NO: 2954  
Repair Type: Non-Urgent  
Crossing Status: Found  
UCIP Comments: Dense vegetation limits the inspector's visibility to identify signs of pipe failure (leaks) along the slope. Recommend removing vegetation along pipe alignment to conduct proper inspection of structure and appurtenances. Note date on photos should be 3/18/09 not 7/26/08 camera metadata is incorrect.  
FIELD\_STRUCT\_DESC: [R.D. No. 349 Drainage Pumping Plant] 3 of 3: 24-inch pipe through the levee, 7.8 feet below the crown. Metal cutoff wall around pipe at landward shoulder. Siphon breakers on waterward slope. Two anchor posts driven into levee on each side of pipe. Pumps on platform on landward side. (Permit No. 2954-1959)  
FS Date: 3/19/2009

View of waterward side--2-24 inch pipes.
